**United States Air Force
611th Air Support Group/
Civil Engineering Squadron**

Remedial Investigation and Feasibility Study

**Cape Lisburne Radar Installation,
Alaska**

**Volume 1 of 2
(Includes Appendices A through B)**

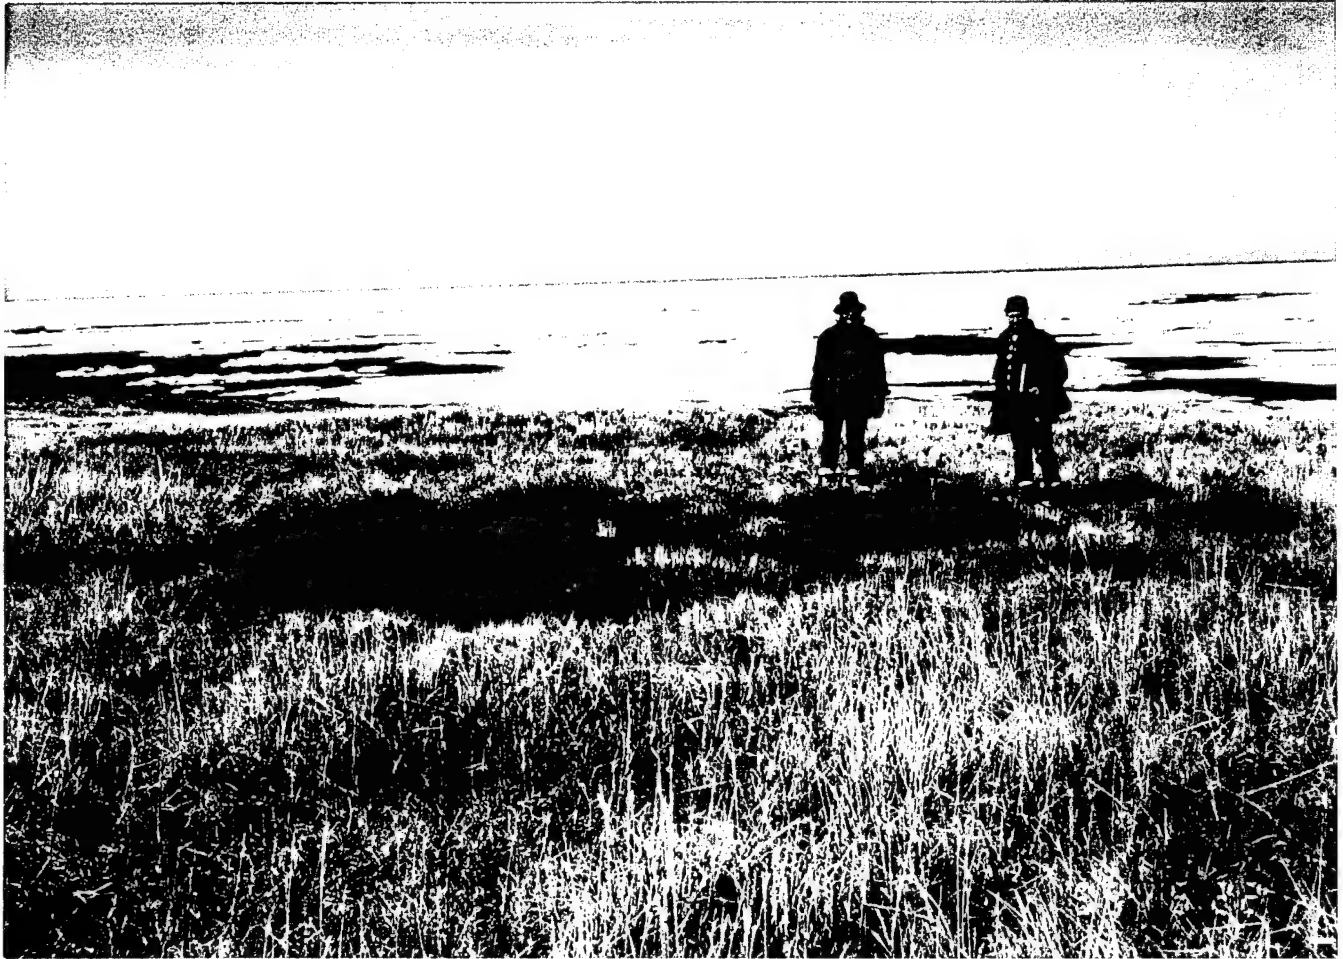
A view to the northwest of the buried drum area at the Landfill and Waste Accumulation Area (LF01) prior to Interim Remedial Actions (IRA) at the site. IRA actions at this site in May 1995 included excavation and containment of approximately 100 drums and associated contaminated soils.

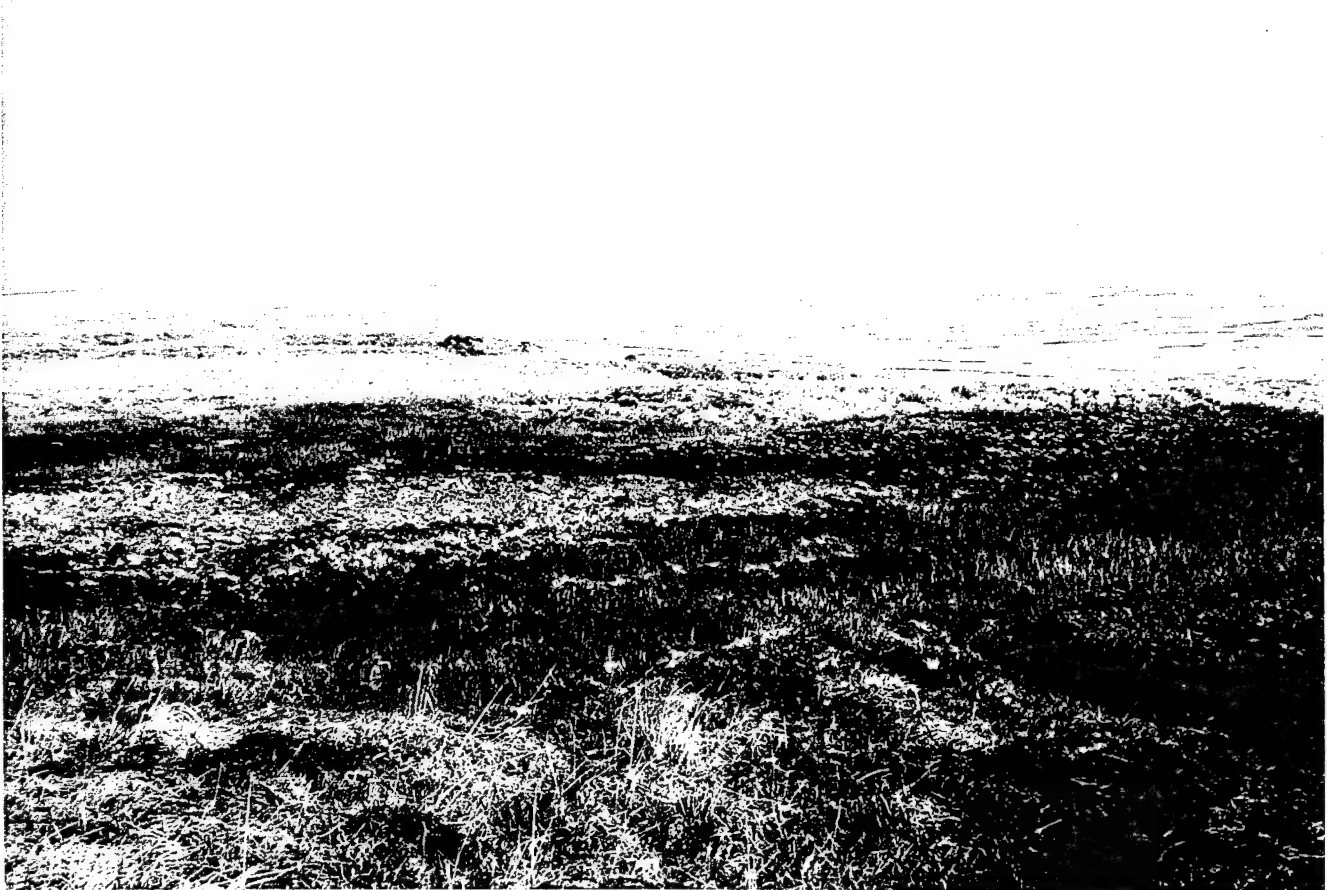
A view to the northwest of the buried drum area after excavation at the Landfill and Waste Accumulation Area (LF01). Clean gravel from the installation's quarry was used to backfill the excavation. The disturbed areas were seeded and fertilized as part of IRA activities.

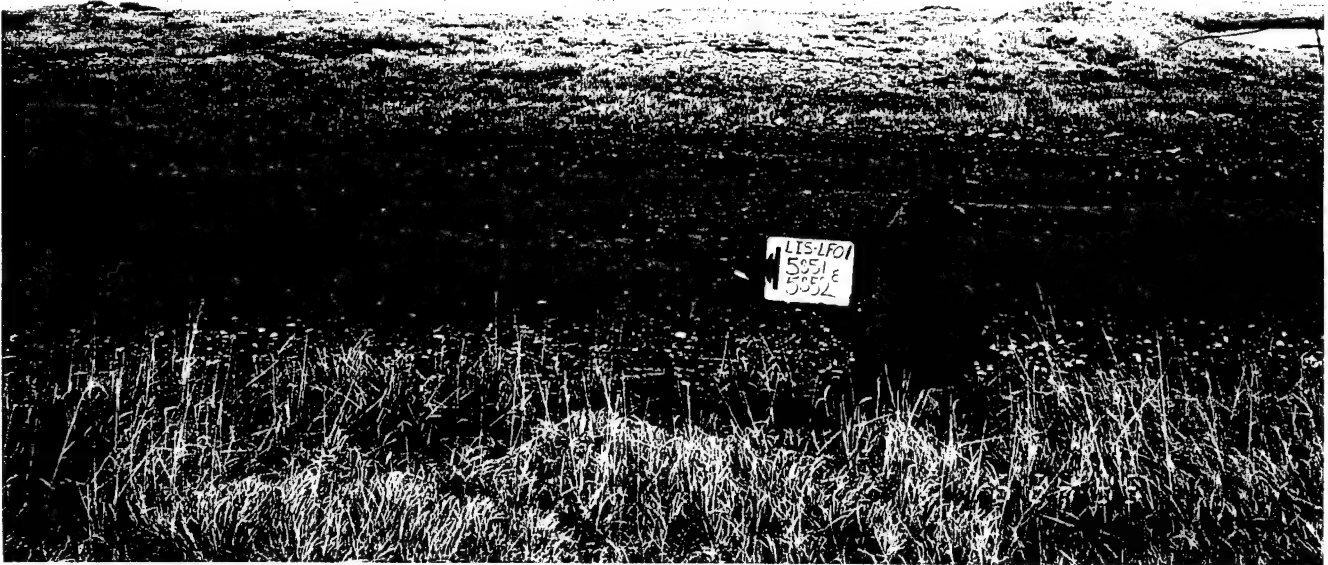
A view to the north of gravel covered area #1 at the Landfill and Waste Accumulation Area (LF01).

Offsite treatment/disposal is recommended as the alternative for remediation of the affected areas at the site (gravel covered areas #1 and #2 and soils in the containment cell). A complete description and evaluation of the remedial alternatives considered for this site and the rationale for the selected alternatives are presented in the Feasibility Study, Section 5.0.

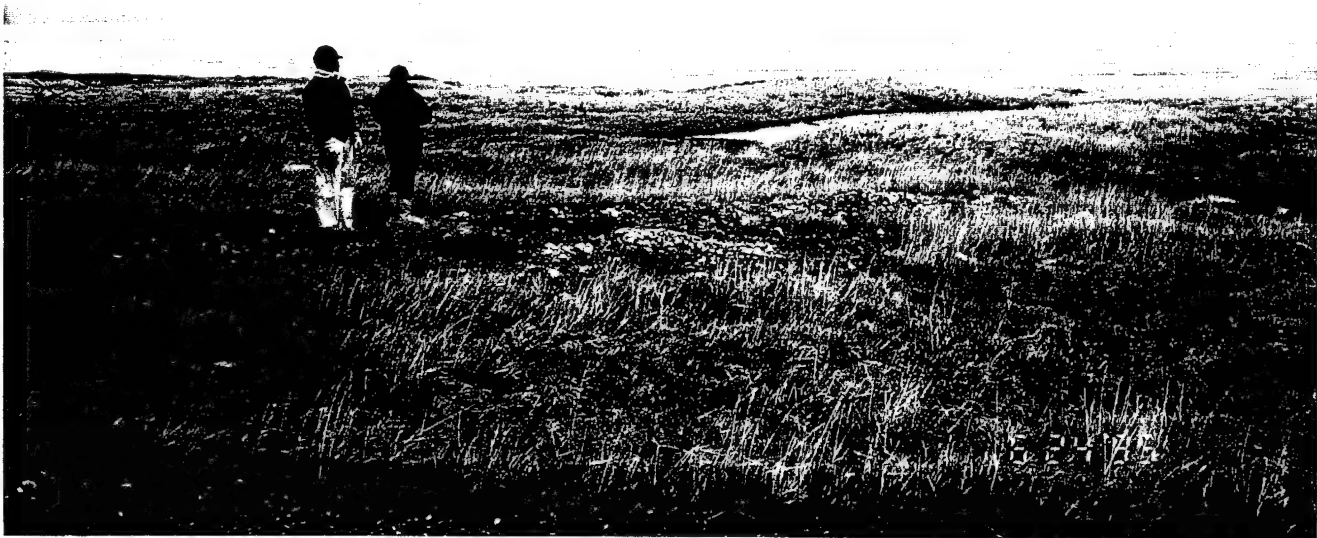
A view to the northwest of gravel covered area #2 at the Landfill and Waste Accumulation Area (LF01). The gravel covered area #1 is located in the middle left side of the photo.

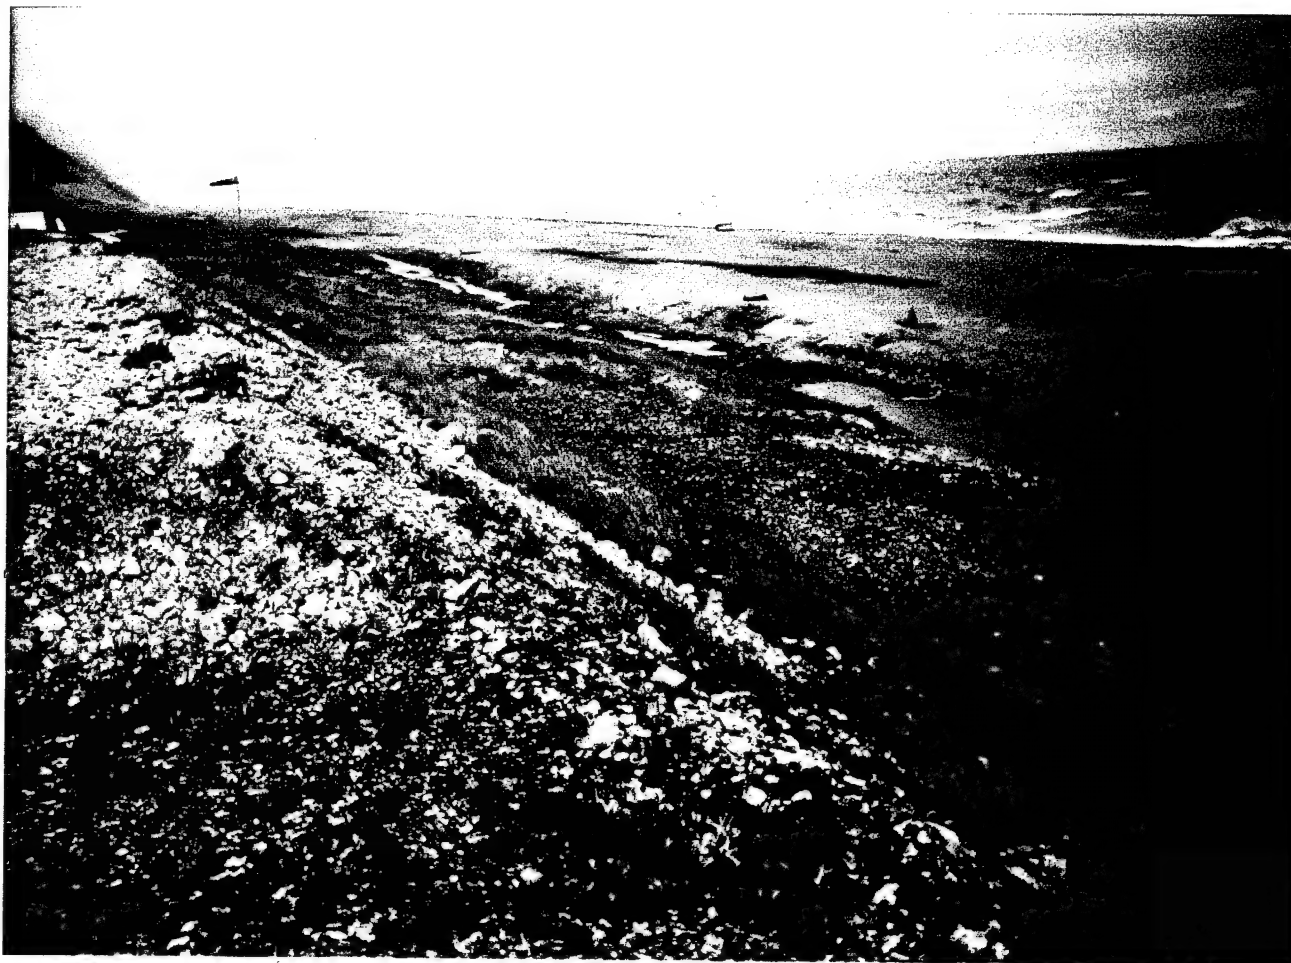
A view to the northeast of the Spill/Leak #3 (ST07) site. Part of the gravel berm surrounding the diesel tanks can be seen to the left.

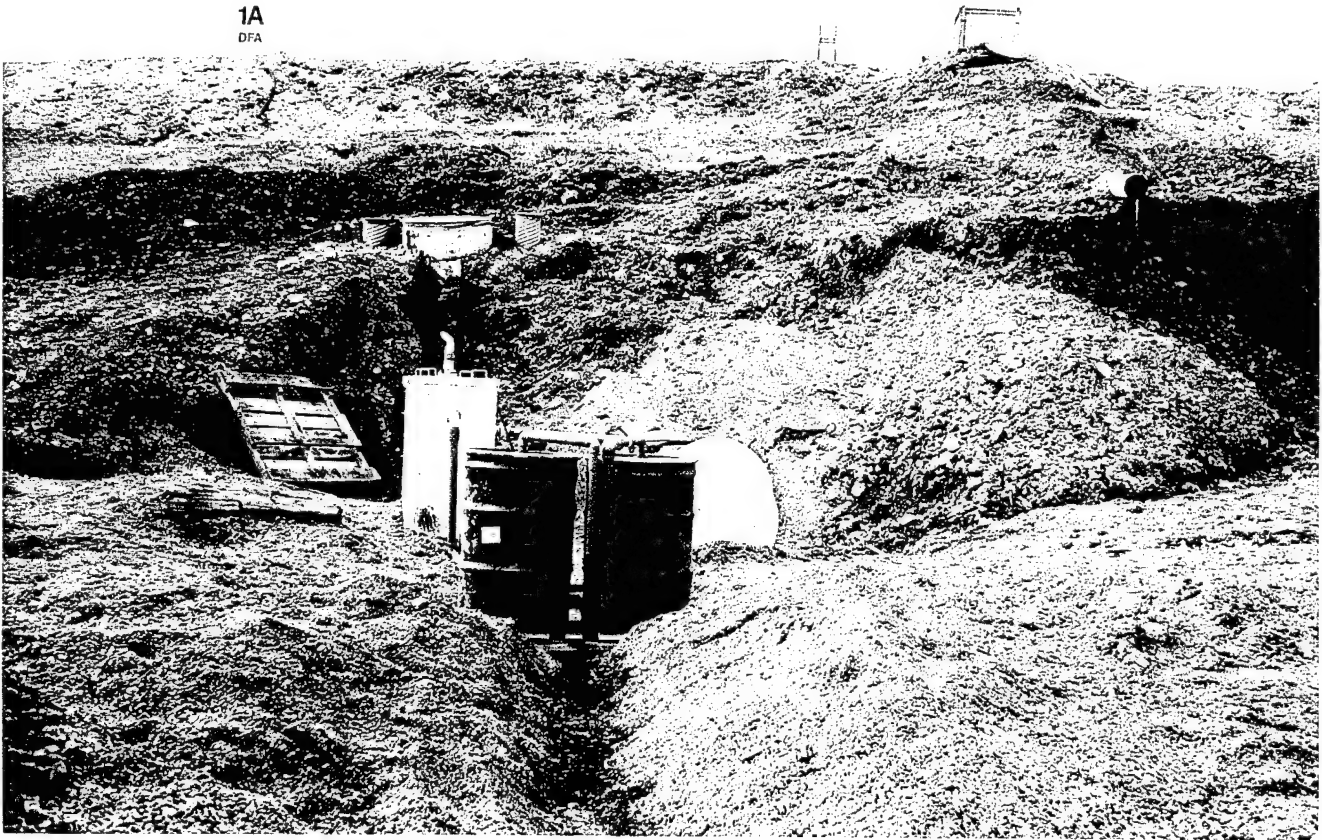
The treatment system at the Spill/Leak #3 (ST07) site consists of an oil/water separator to remove diesel product and carbon adsorption units for treating water collected by the system.

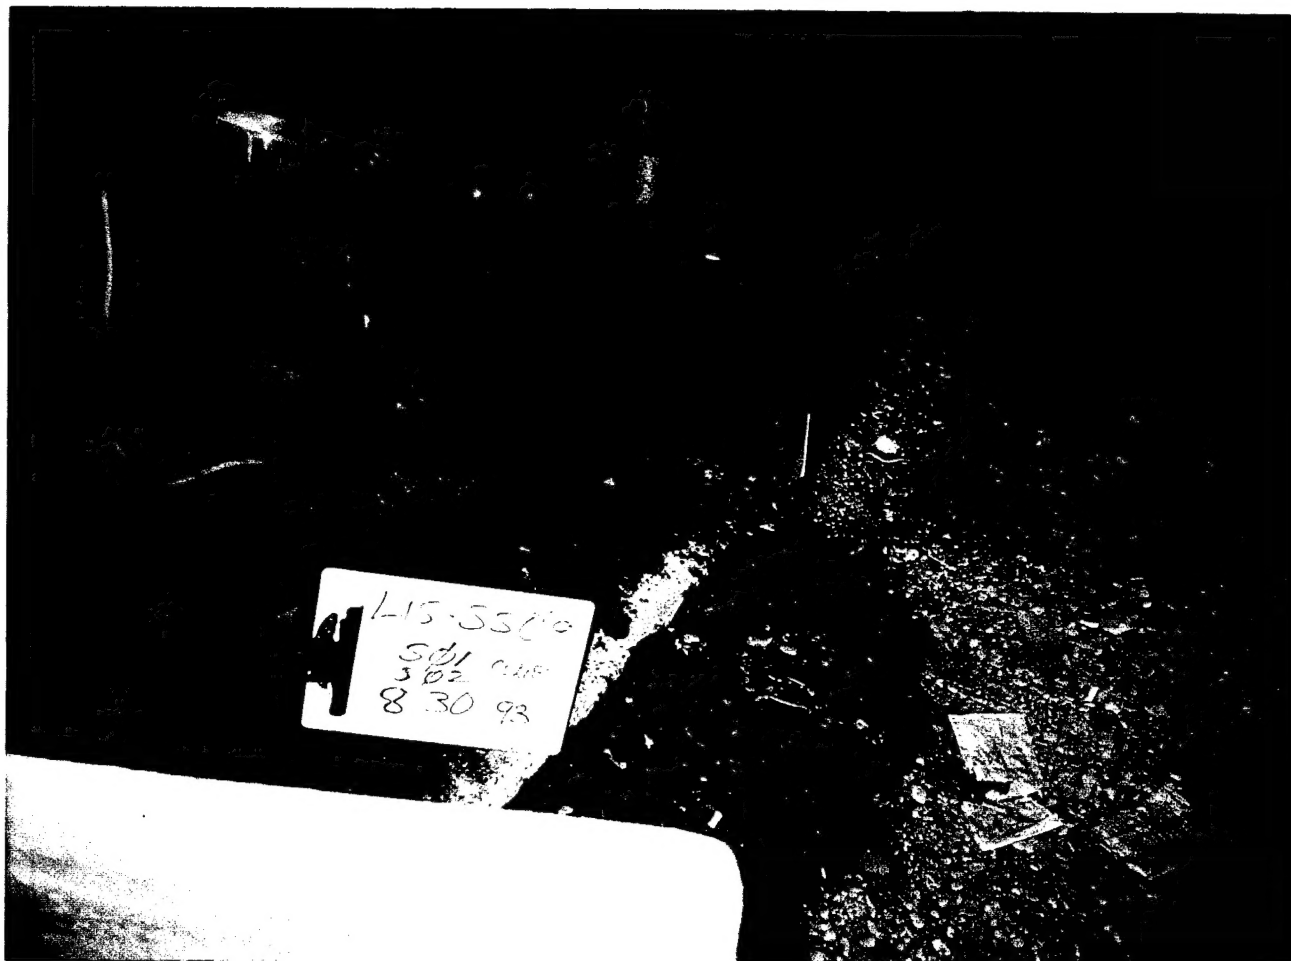
Staining is apparent on the concrete pad and on the adjacent soil inside the Lower Camp Transformer Buildings (SS09) site.

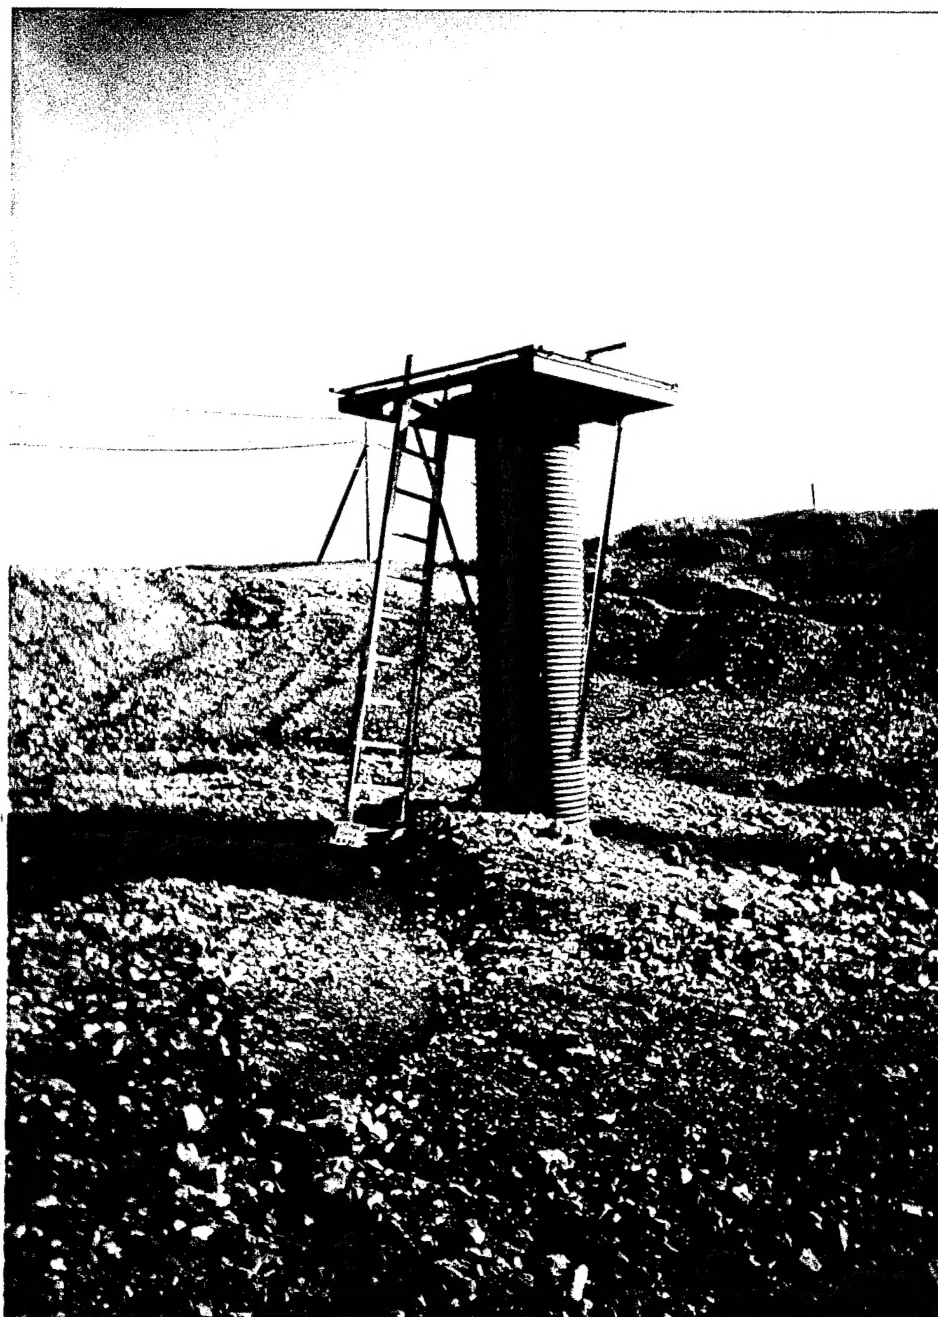
This standpipe located at Selin Creek is part of the Water Gallery (AOC3). This view is to the northeast.
